The Ins and Outs of a TSCA Self-Implemented Cleanup Including PCB Bulk Product Waste

Laura McNamara, P.E., PMP

HydroGeoLogic, Inc.

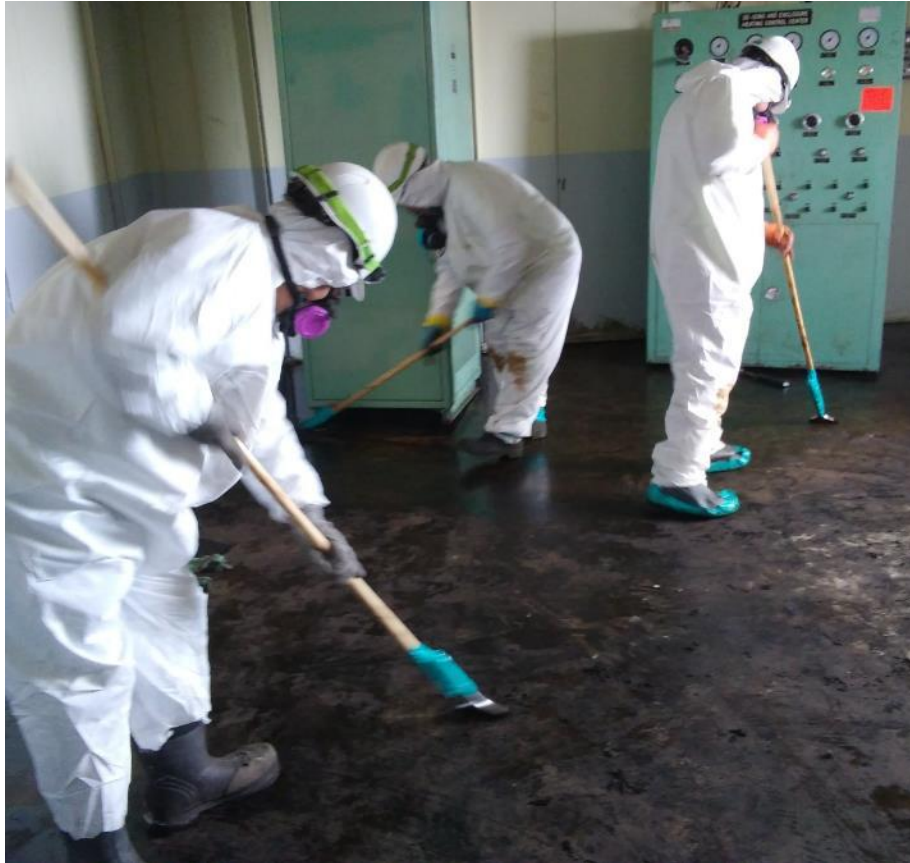
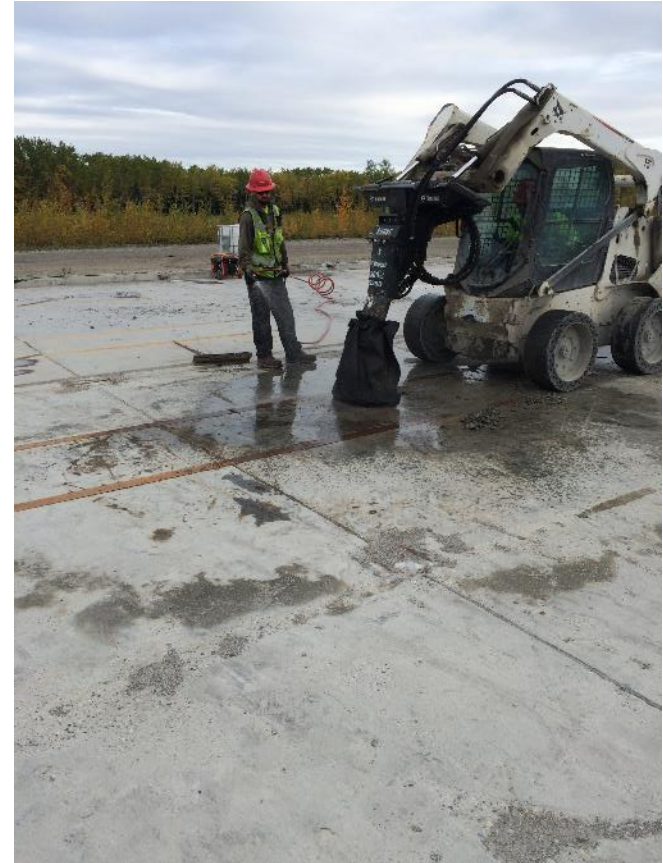
Project Execution - Remediation

- ▼ During execution, EPA approved the following remediation techniques:
 - High efficiency particulate air vacuuming of loose paint chips.
 - Removal of oil from non-porous surfaces using cleaner and rags.
 - Scabbling of paint/oil staining from concrete to be left in place.
- ▼ Paint chips, rags, and scabbled paint/concrete were then containerized, characterized and disposed of as PCB remediation waste.

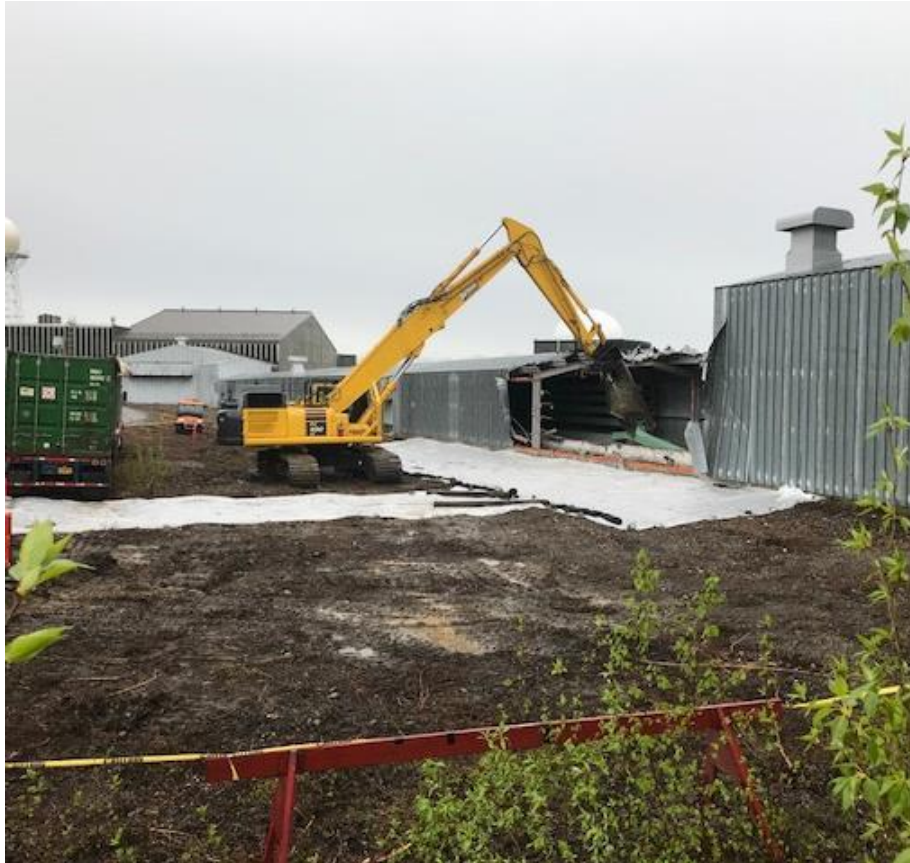
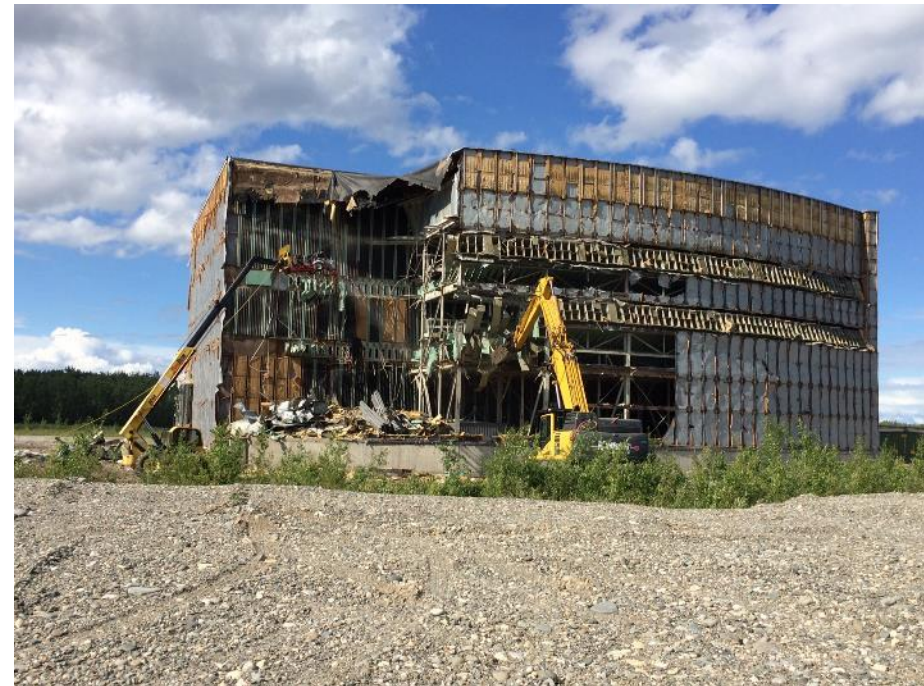
Project Execution - Demolition

- ACM and ORM abatement were completed prior to structure demolition;
- All paint in the facility contained PCBs and met the definition of bulk product waste;
- Only non-stained, non-painted debris was considered clean construction and demolition (C&D) waste; and
- Stained concrete was assumed to be remediation waste with concentrations <50 ppm.

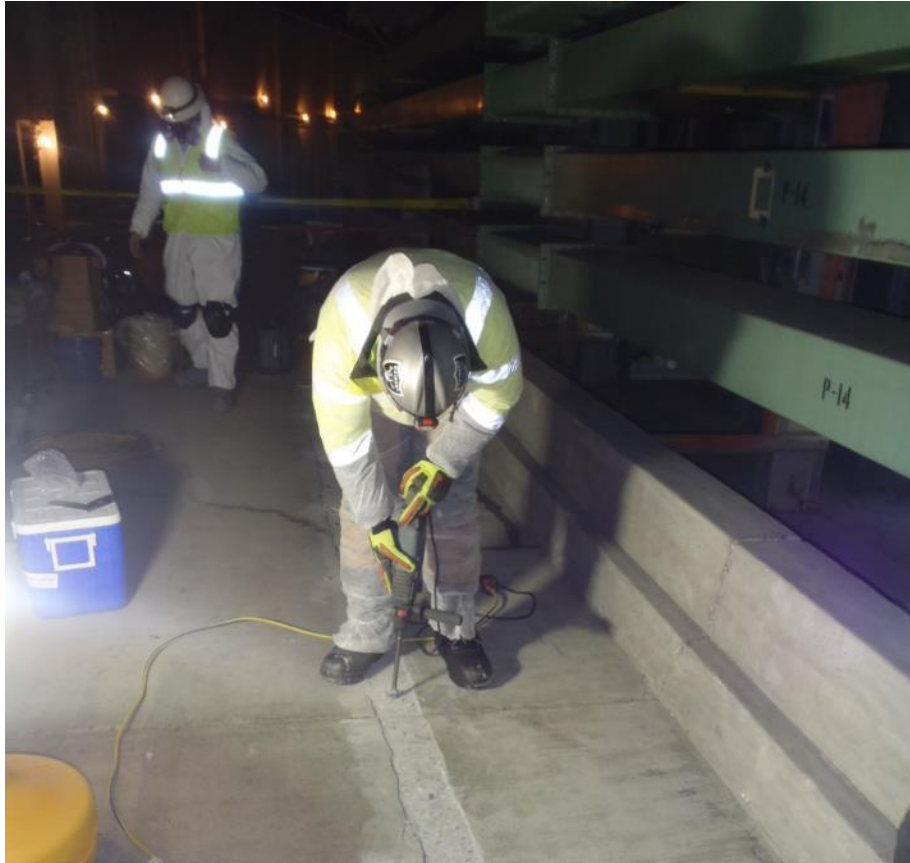
Project Execution – Additional Sampling

- ▼ Based on uncertainties in the characterization data, HGL completed additional characterization sampling of concrete slated for demolition in 2019:
 - Total of 114 concrete samples were collected
 - 44 samples contained PCBs <1 ppm (disposal limit within Alaska)
 - 70 samples contained PCBs >1 ppm
 - None of the samples contained PCBs >50 ppm
- ▼ HGL confirmed that the concrete slated for demolition and disposal required out of state disposal as non-hazardous waste (not a TCSA waste).

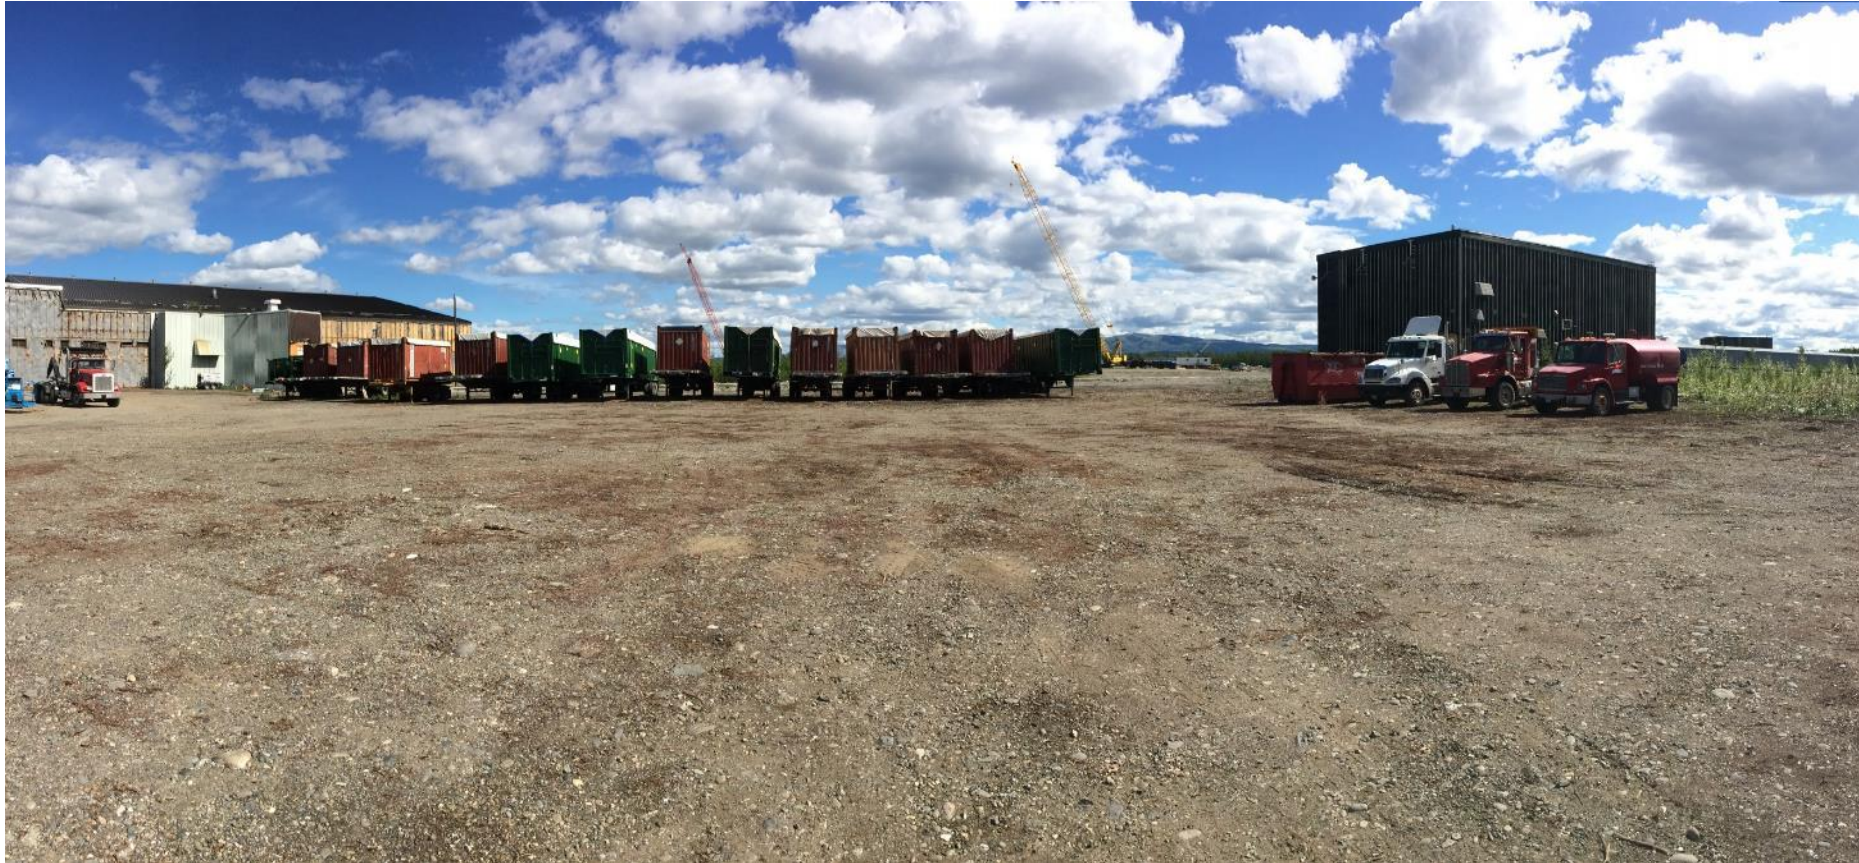
Project Execution – Waste Segregation

▼ Improper segregation can lead to:

- Material being incorrectly manifested and disposal in the wrong landfill.
- Regulatory violations and efforts to retrieve the material for proper disposal.

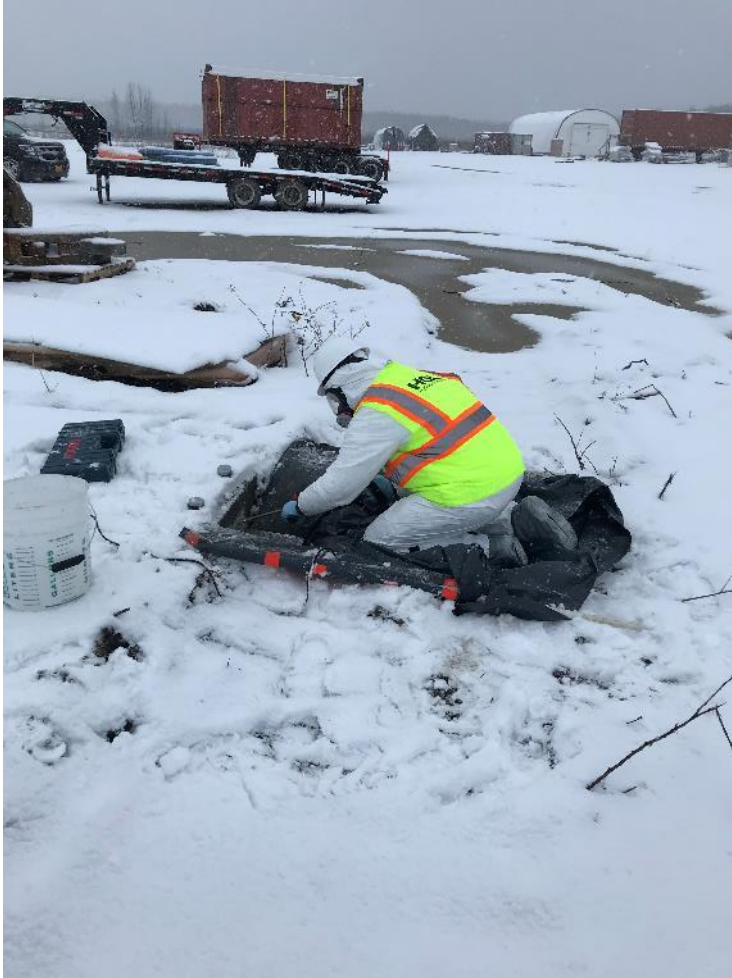
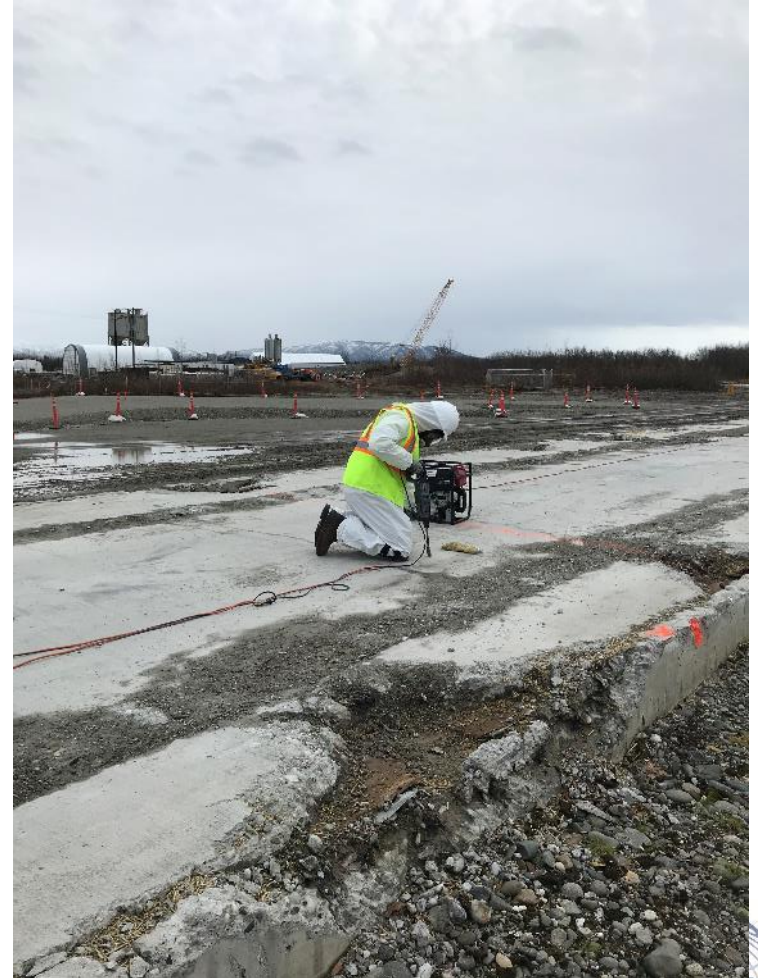
Project Execution – Post-Demolition Sampling

- Composite sampling of foundation top surfaces
 - 9-point composites over either 900 ft² or 1,800 ft² grids
 - Samples collected from 0.5-inch depth
- Discrete sampling of foundation vertical edges
 - Sample locations every 100 ft
 - Two sample depths per location: 1/8-inch depth and 1/8- to 3/4-inch depth
 - Soil samples adjacent to vertical sample locations

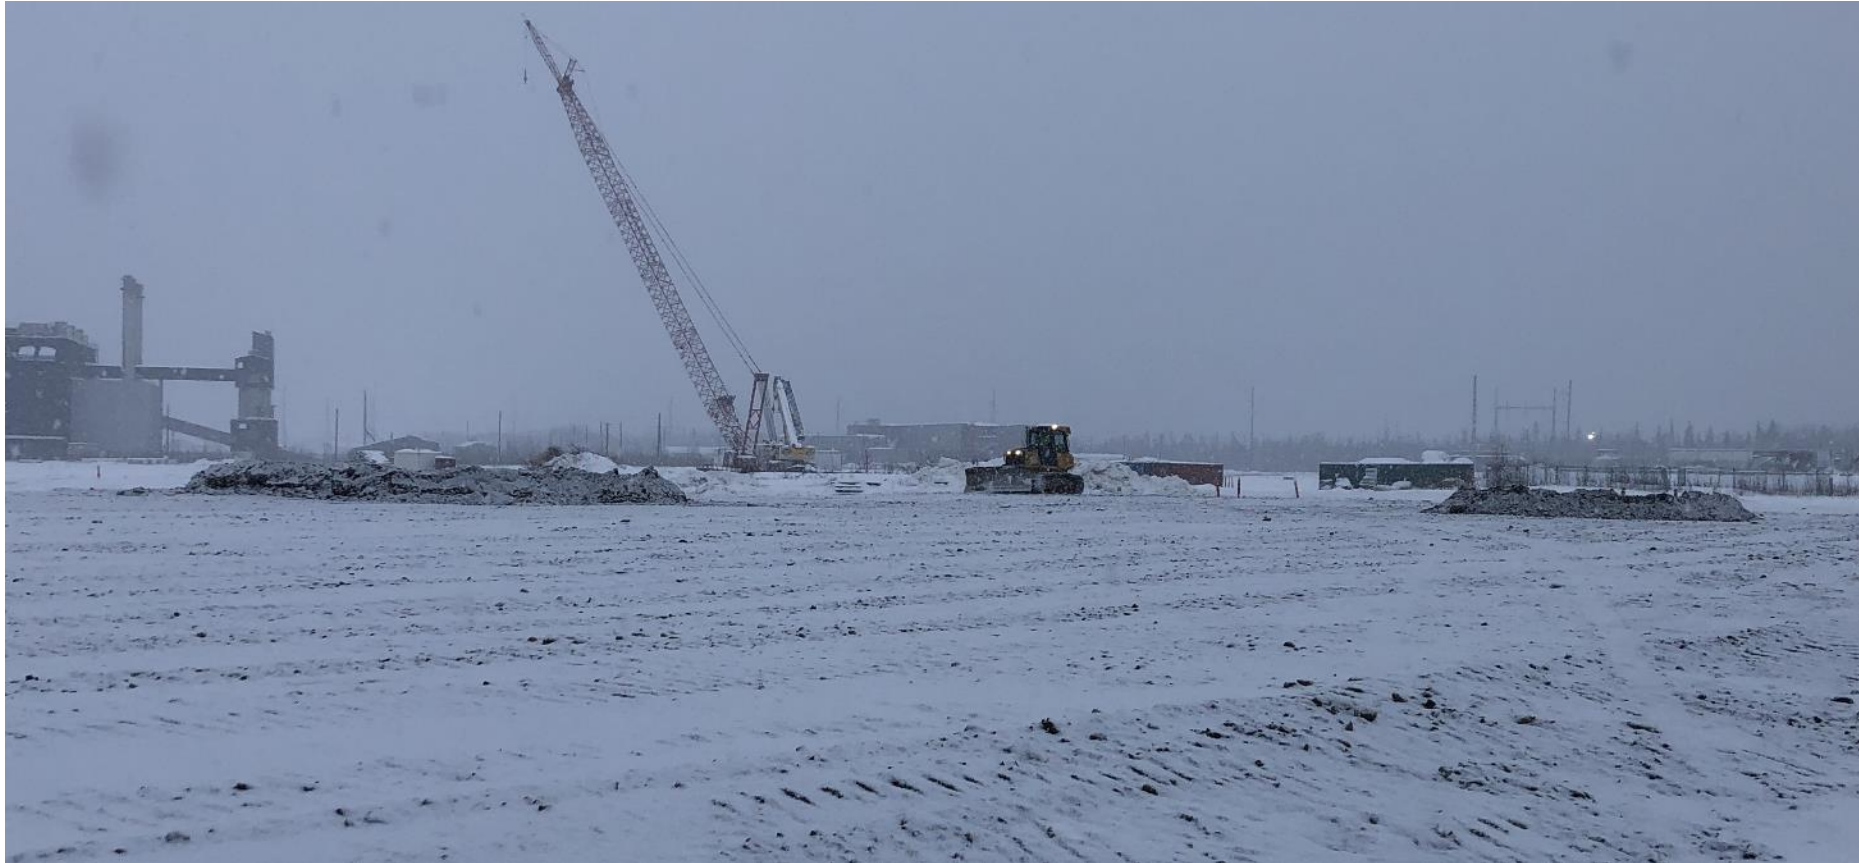
Site Closure

▼ The foundations of the buildings were always planned to be left in place and covered with soil.
